2022

Skogman Lake Shoreline Assessment

Todd Kulaf, Conservation Specialist
Isanti Soil and Water Conservation District

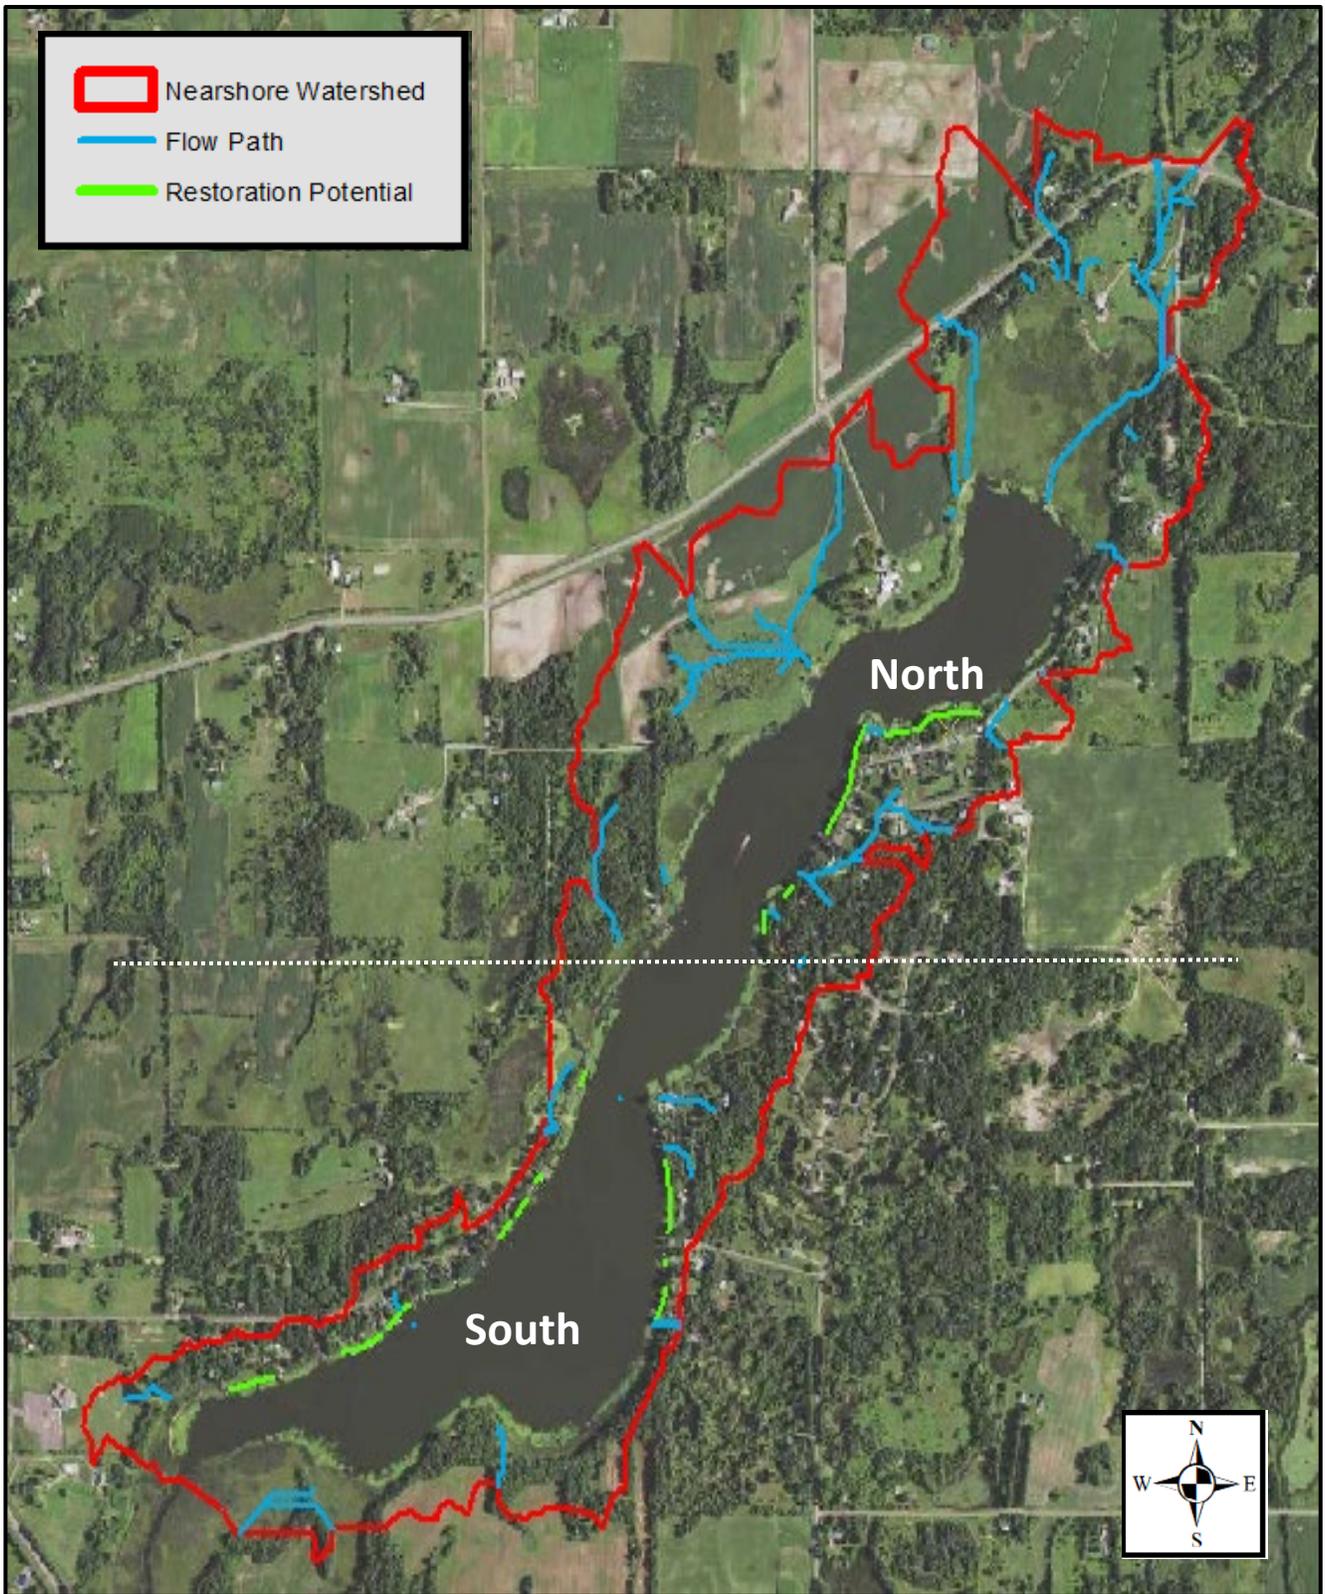
Map1: Overview Map

The primary focus of this report was identifying resource concerns directly adjacent to the lake and potential options for addressing those concerns. A total of 3,467 linear feet of shoreline was identified as benefitting from a shoreline restoration. If 65% of that total (2,256 ln/ft) was restored, we estimate a phosphorus (P) reduction of 7.0 pounds annually (1lb. of P can produce 500lbs. of algae).

Overall, the shoreline is in good condition in terms of erosion. Much of the shoreline is lined with rock rip-rap, which does not provide any stormwater filtering benefits but has some benefits when addressing shoreline loss/erosion. The main resource concern is the potential for undesirable nutrients reaching the lake via stormwater runoff. Almost half of the Skogman Lake shoreline is residentially developed. Also, much of the development is high density. Typically, high density residential areas result a significant amount of impervious surface (roofs, driveways, sidewalks). These conditions hinder natural stormwater filtering and increases the volume of stormwater and nutrient reaching the lake. Furthermore, manicured lawns and landscaping are typical land use for residential lakeshore. These land use characteristics generally are not ideal for protecting lake water quality.

The majority of the shoreline identified, for restoration opportunities, is adjacent to high density residential areas. Like many similar shorelines in Minnesota, the main resource concern around Skogman Lake is the lack of vegetative shoreline buffer. Installing shoreline buffers and erosion control methods, has the potential to improve and protect water quality in Skogman Lake.

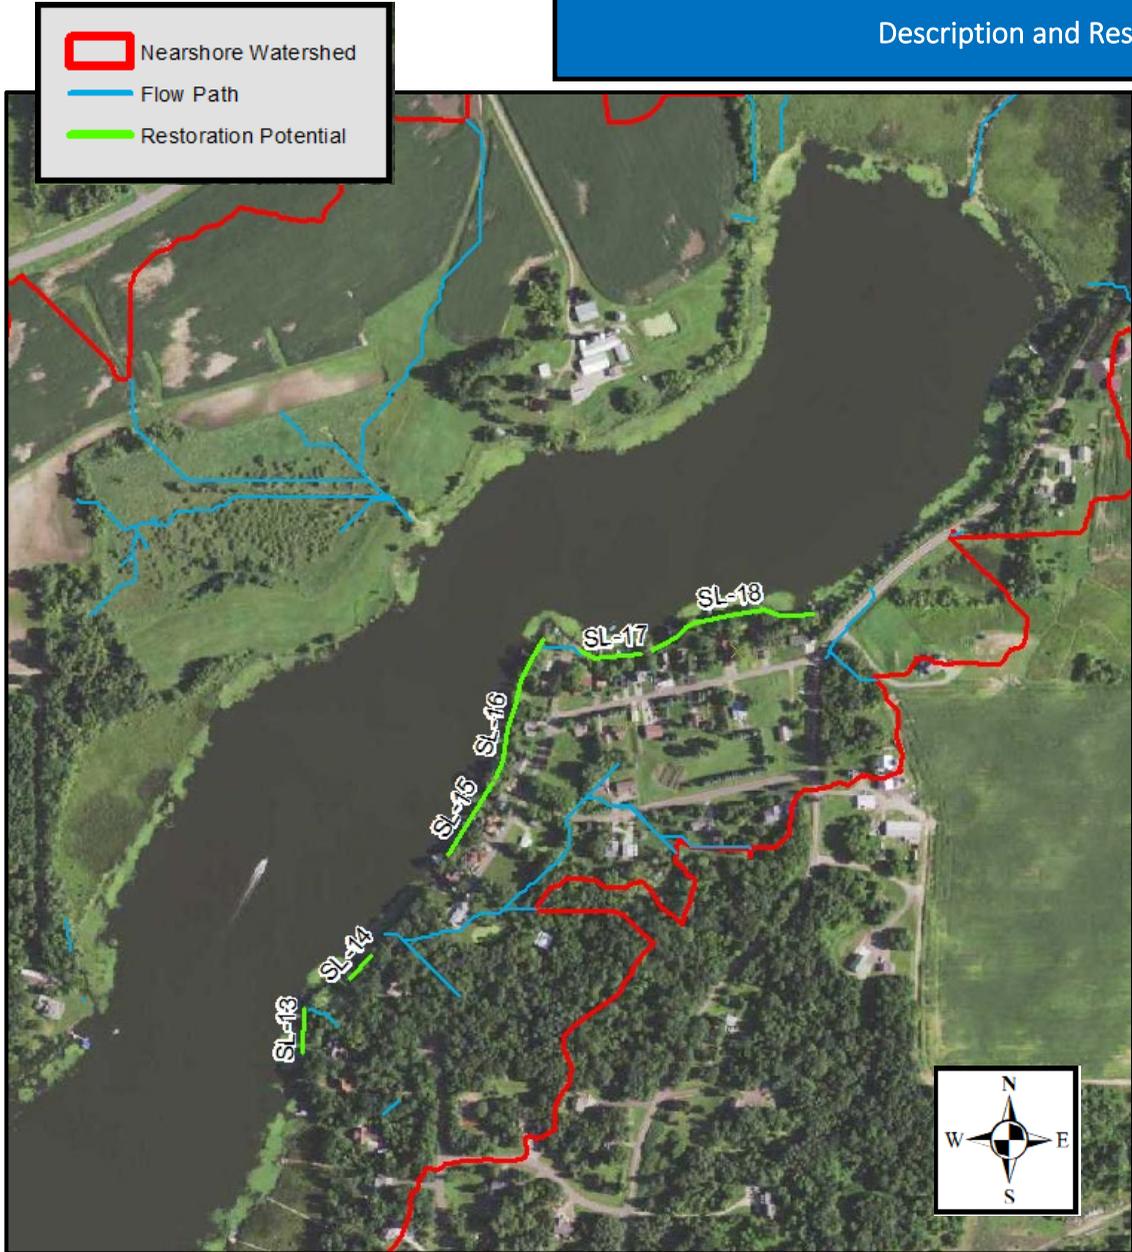
North Shoreline: Description and Restoration Recommendation

On the north end of Skogman Lake, a total of 928 linear feet of shoreline was identified for potential restoration opportunities. If all 928 linear feet was addressed, an estimated 3.0 pounds of phosphorus would be prevented from flowing into the lake each year. One the North end of the lake, identified shorelines were labeled from SL- 13 to SL 18. Information on each identified shoreline is outlined in this report.

Shoreline Restorations		
<i>Cost/Removal Analysis</i>		
Treatment	Total Buffer Depth ft.	15
	Shoreline Addressed Lft.	928
	TP (lb/yr)	3.0
	TSS (lb/yr)	2,467
Cost	Design Costs and Admin	\$4,000
	Construction Costs and Material**	\$59,600
	Total Estimated Project Cost	\$63,600
	Annual O&M***	\$50
Efficiency	30-yr Average Cost/lb-TP	\$728

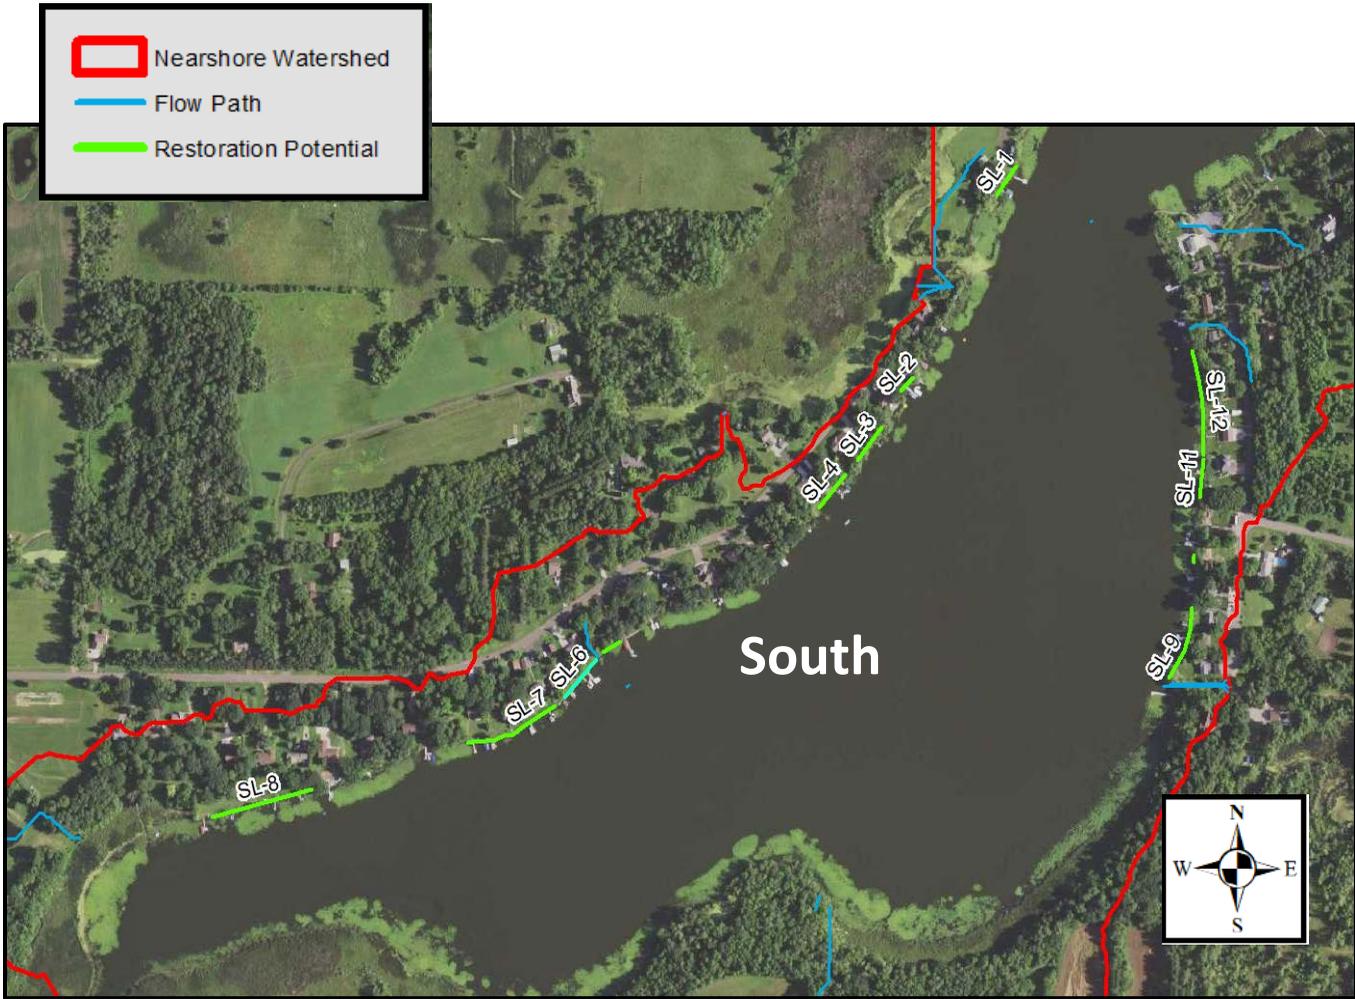
South Shoreline: Description and Restoration Recommendation

On the South end of Skogman Lake, a total of 1,328 linear feet of shoreline was identified for potential restoration opportunities. If all 1,328 linear feet was addressed, an estimated 3.9 pounds of phosphorus would be prevented from flowing into the lake each year. One the south end of the lake, identified shorelines were labeled from SL- 1 to SL 12. Information on each identified shoreline is outlined in this report.

Shoreline Restorations		
<i>Cost/Removal Analysis</i>		
Treatment	Total Buffer Depth ft.	15
	Shoreline Addressed Lnft.	1,328
	TP (lb/yr)	3.9
	TSS (lb/yr)	2,747
Cost	Design Costs and Admin	\$5,000
	Construction Costs and Material**	\$89,600
	Total Estimated Project Cost	\$94,600
	Annual O&M***	\$50
Efficient	30-yr Average Cost/lb-TP	\$831

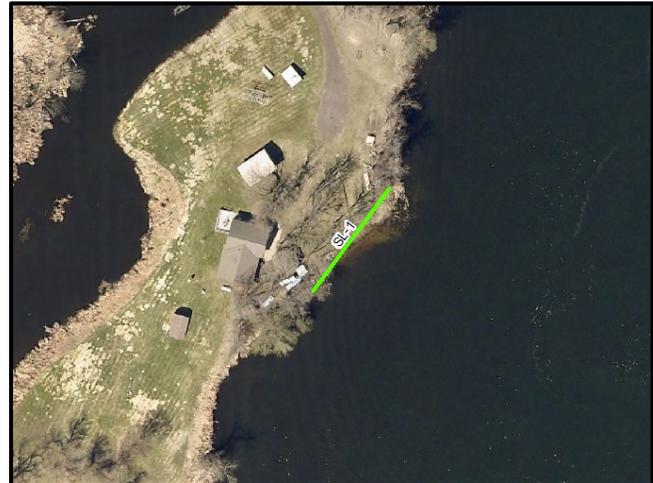
Shoreline 1: Description and Restoration Recommendation

Existing Shoreline Summary	
Watershed Acres	.22
Land Management	Beach and Lawn
TP (lbs/yr)	.34
Shore Erosion Severity	Mild

Location – Southwest shore of Skogman Lake
Project recommendation: Shoreline Restoration

For this section of shoreline, a basic shoreline restoration is proposed. Based on the shoreline characteristics, installing a native plant buffer along the shoreline will help capture and filter stormwater runoff from the watershed as well as stabilize the shoreline soils. In addition to the vegetative buffer, installing a biolog or willow bundles at the water’s edge will reduce soil loss and erosion from excessive wave action as well as encourage the success of the native plant buffer.

Shoreline Restoration		
<i>Cost/Removal Analysis</i>		
Treatment	Total Buffer Depth ft.	15
	Shoreline Addressed Lnft.	68
	TP (lb/yr)	0.2
	TSS (lb/yr)	162
	Cost	Total Estimated Project Cost
Annual O&M***		\$50
Efficiency	30-yr Average Cost/lb-TP	\$1,352

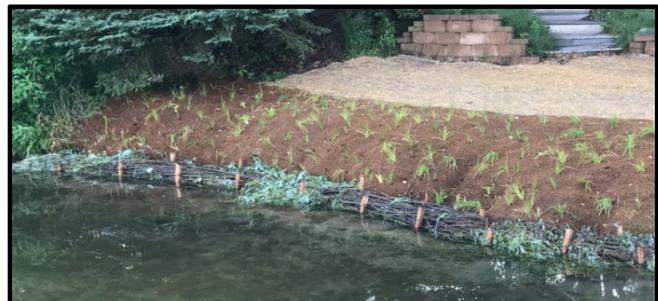
Native Plant Buffer and Willow Bundle

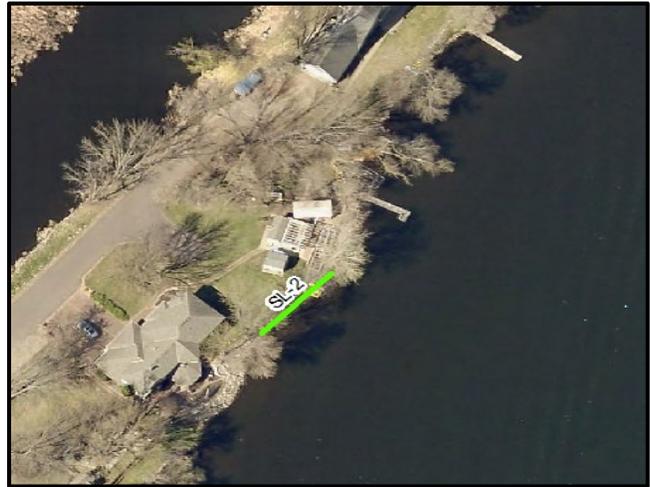
Shoreline 2: Description and Restoration Recommendation

Existing Shoreline Summary	
Watershed Acres	.05
Land Management	Lawn
TP (lbs/yr)	.1
Shore Erosion Severity	Minimal

Location – Southwest shore of Skogman Lake

Project recommendation: Shoreline Restoration

For this section of shoreline, a basic shoreline restoration is proposed. Based on the shoreline characteristics, installing a native plant buffer along the shoreline will help capture and filter stormwater runoff from the watershed as well as stabilize the shoreline soils. In addition to the vegetative buffer, installing a biolog or willow bundles at the water’s edge will reduce soil loss and erosion from excessive wave action as well as encourage the success of the native plant buffer.

Lakeshore Restorations		
Cost/Removal Analysis		
Treatment	Total Buffer Depth ft.	1
	Shoreline Addressed Lnft.	46
	TP (lb/yr)	0.1
	TSS (lb/yr)	71
	Total Estimated Project Cost	\$4,450
Cost	Annual O&M***	\$50
	30-yr Average Cost/lb-TP	\$2,366

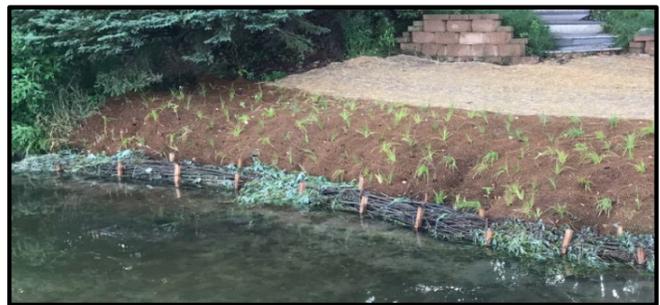
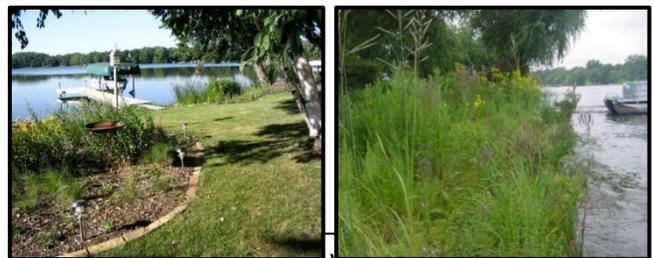
Native Plant Buffer and Willow Bundle

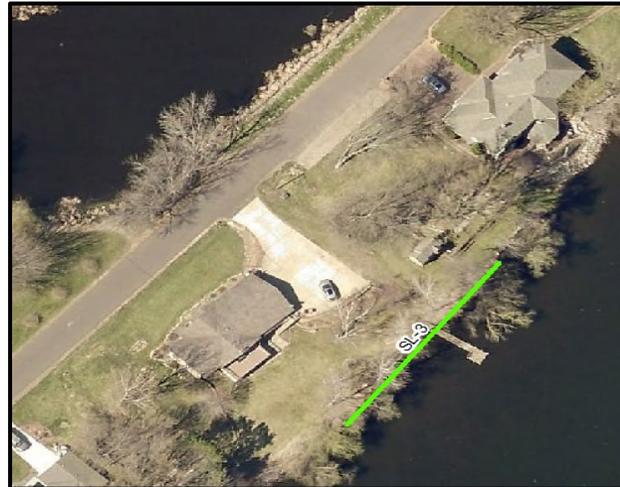
Shoreline 3: Description and Restoration Recommendation

Existing Shoreline Summary	
Watershed Acres	.32
Land Management	Lawn
TP (lbs/yr)	.25
Shore Erosion Severity	Minimal

Location – Southwest shore of Skogman Lake
Project recommendation: Shoreline Restoration

For this section of shoreline, a basic shoreline restoration is proposed. Based on the shoreline characteristics, installing a native plant buffer along the shoreline will help capture and filter stormwater runoff from the watershed as well as stabilize the shoreline soils. In addition to the vegetative buffer, installing a biolog or willow bundles at the water’s edge will reduce soil loss and erosion from excessive wave action as well as encourage the success of the native plant buffer.

Shoreline Restorations		
Cost/Removal Analysis		
Treatment	Total Buffer Depth ft.	15
	Shoreline Addressed Lnft.	105
	TP (lb/yr)	0.2
	TSS (lb/yr)	170
	Cost	Total Estimated Project Cost
Annual O&M***		\$50
Efficiency	30-yr Average Cost/lb-TP	\$1,582

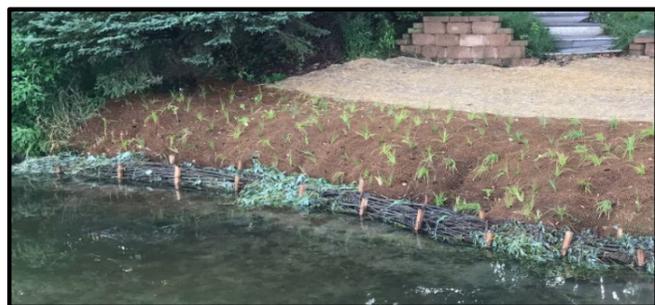
Native Plant Buffer and Willow Bundle

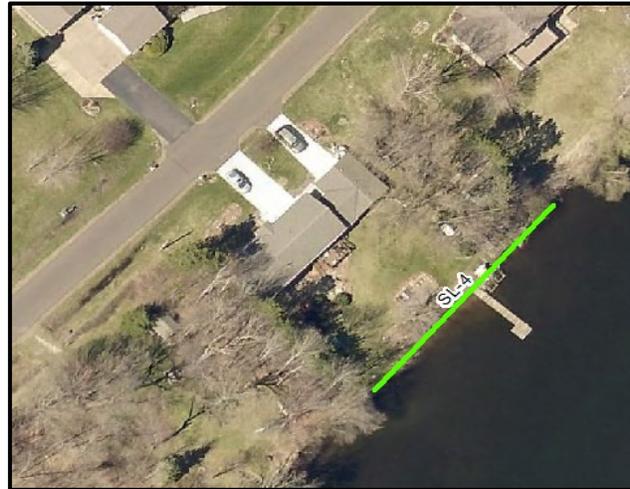
Shoreline 4: Description and Restoration Recommendation

Existing Shoreline Summary	
Watershed Acres	.8
Land Management	Lawn/Beach/Rock
TP (lbs/yr)	.54
Shore Erosion Severity	Minimal

Location – Southwest shore of Skogman Lake

Project recommendation: Shoreline Restoration

For this section of shoreline, a basic shoreline restoration is proposed. Based on the shoreline characteristics, installing a native plant buffer along the shoreline will help capture and filter stormwater runoff from the watershed as well as stabilize the shoreline soils. In addition to the vegetative buffer, installing a biolog or willow bundles at the water’s edge will reduce soil loss and erosion from excessive wave action as well as encourage the success of the native plant buffer.

Shoreline Restorations		
<i>Cost/Removal Analysis</i>		
Treatment	Total Buffer Depth ft.	15
	Shoreline Addressed Lft.	108
	TP (lb/yr)	0.3
	TSS (lb/yr)	198
Cost	Total Estimated Project Cost	\$9,100
	Annual O&M***	\$50
Efficiency	30-yr Average Cost/lb-TP	\$1,214

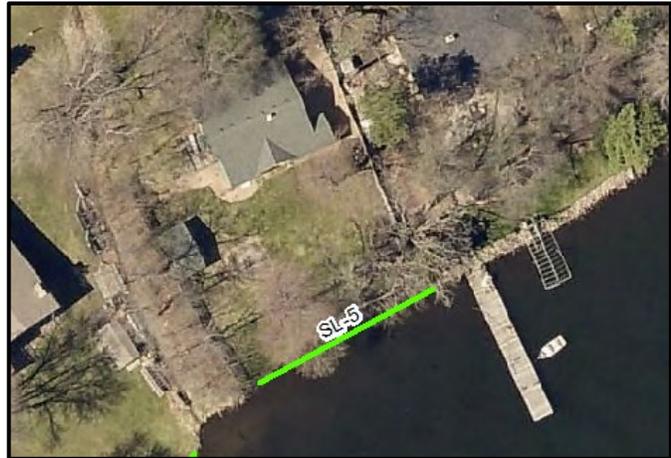
Shoreline 5: Description and Restoration Recommendation

Existing Shoreline Summary	
Watershed Acres	.7
Land Management	Lawn
TP (lbs/yr)	.34
Shore Erosion Severity	Minimal

Location – Southwest shore of Skogman Lake

Project recommendation: Shoreline Restoration

For this section of shoreline, a basic shoreline restoration is proposed. Based on the shoreline characteristics, installing a native plant buffer along the shoreline will help capture and filter stormwater runoff from the watershed as well as stabilize the shoreline soils. In addition to the vegetative buffer, installing a biolog or willow bundles at the water’s edge will reduce soil loss and erosion from excessive wave action as well as encourage the success of the native plant buffer.

Shoreline Restorations		
Cost/Removal Analysis		
Treatment	Total Buffer Depth ft.	15
	Shoreline Addressed Lnft.	54
	TP (lb/yr)	0.2
	TSS (lb/yr)	162
	Total Estimated Project Cost	\$5,050
Cost	Annual O&M***	\$50
	30-yr Average Cost/lb-TP	\$1,116

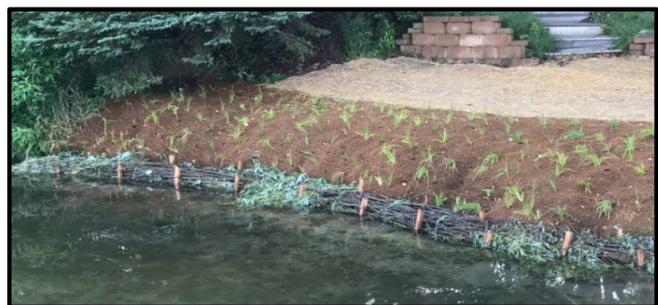
Native Plant Buffer and Willow Bundle

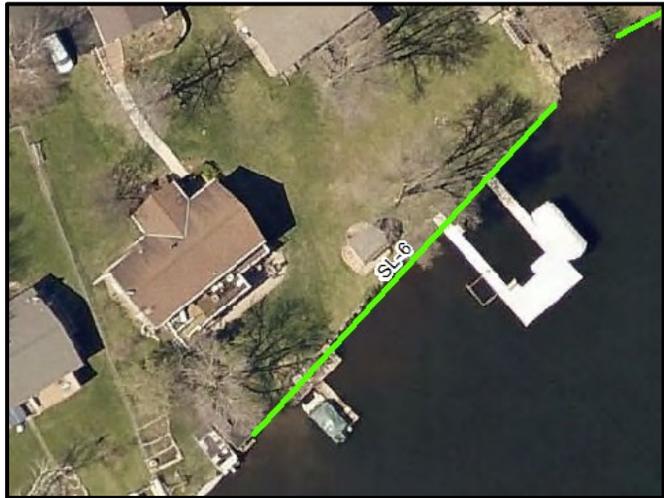
Shoreline 6: Description and Restoration Recommendation

Existing Shoreline Summary	
Watershed Acres	3.6
Land Management	Lawn
TP (lbs/yr)	.5
Shore Erosion Severity	Minimal

Location – Southwest shore of Skogman Lake
Project recommendation: Shoreline Restoration

For this section of shoreline, a basic shoreline restoration is proposed. Based on the shoreline characteristics, installing a native plant buffer along the shoreline will help capture and filter stormwater runoff from the watershed as well as stabilize the shoreline soils. In addition to the vegetative buffer, installing a biolog or willow bundles at the water’s edge will reduce soil loss and erosion from excessive wave action as well as encourage the success of the native plant buffer.

Shoreline Restorations		
Cost/Removal Analysis		
Treatment	Total Buffer Depth ft.	15
	Shoreline Addressed Lnft.	110
	TP (lb/yr)	0.3
	TSS (lb/yr)	218
	Cost	Total Estimated Project Cost
Annual O&M***		\$50
Efficiency	30-yr Average Cost/lb-TP	\$1,224

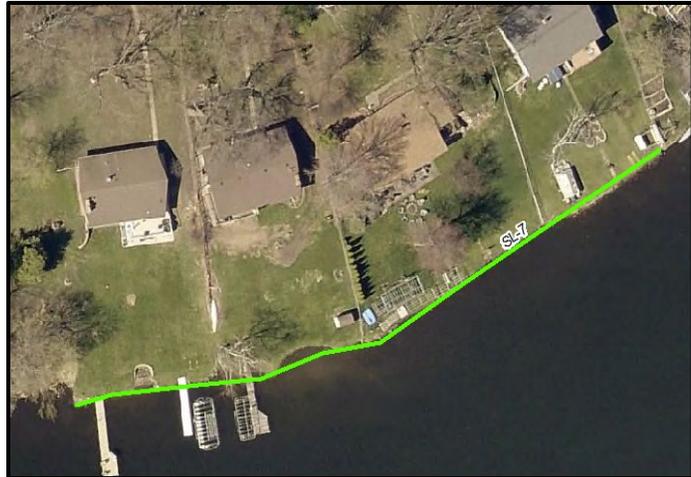
Shoreline 7: Description and Restoration Recommendation

Existing Shoreline Summary	
Watershed Acres	1.35
Land Management	Lawn/rock
TP (lbs/yr)	1.0
Shore Erosion Severity	Minimal

Location – Southwest shore of Skogman Lake

Project recommendation: Shoreline Restoration

For this section of shoreline, a basic shoreline restoration is proposed. Based on the shoreline characteristics, installing a native plant buffer along the shoreline will help capture and filter stormwater runoff from the watershed as well as stabilize the shoreline soils. In addition to the vegetative buffer, installing a biolog or willow bundles at the water’s edge will reduce soil loss and erosion from excessive wave action as well as encourage the success of the native plant buffer.

Shoreline Restorations		
Cost/Removal Analysis		
Treatment	Total Buffer Depth ft.	15
	Shoreline Addressed Lft.	225
	TP (lb/yr)	0.6
	TSS (lb/yr)	431
Cost	Total Estimated Project Cost	\$17,875
	Annual O&M***	\$50
Efficiency	30-yr Average Cost/lb-TP	\$1,009

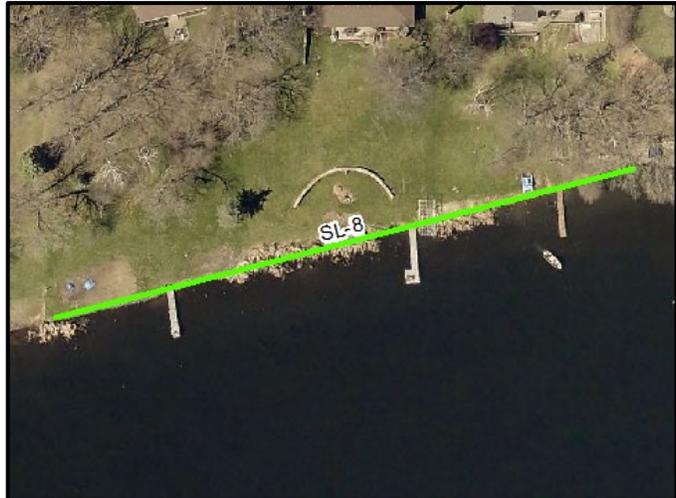
Shoreline 8: Description and Restoration Recommendation

Existing Shoreline Summary	
Watershed Acres	2.2
Land Management	Lawn
TP (lbs/yr)	1.0
Shore Erosion Severity	Minimal

Location – Southwest shore of Skogman Lake

Project recommendation: Shoreline Restoration

For this section of shoreline, a basic shoreline restoration is proposed. Based on the shoreline characteristics, installing a native plant buffer along the shoreline will help capture and filter stormwater runoff from the watershed as well as stabilize the shoreline soils. In addition to the vegetative buffer, installing a biolog or willow bundles at the water’s edge will reduce soil loss and erosion from excessive wave action as well as encourage the success of the native plant buffer.

Shoreline Restorations		
Cost/Removal Analysis		
Treatment	Total Buffer Depth ft.	15
	Shoreline Addressed Lnft.	243
	TP (lb/yr)	0.9
	TSS (lb/yr)	534
Cost	Design Costs and Admin	\$1,000
	Annual O&M***	\$50
Efficiency	30-yr Average Cost/lb-TP	\$747

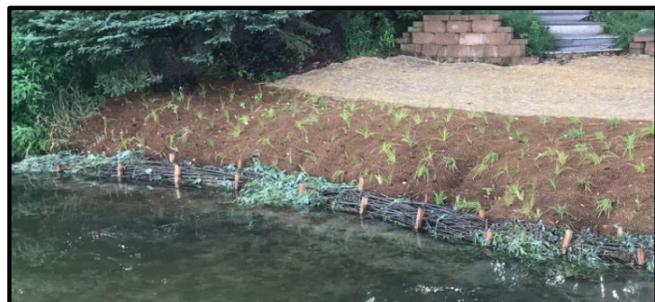
Native Plant Buffer and Willow Bundle Example

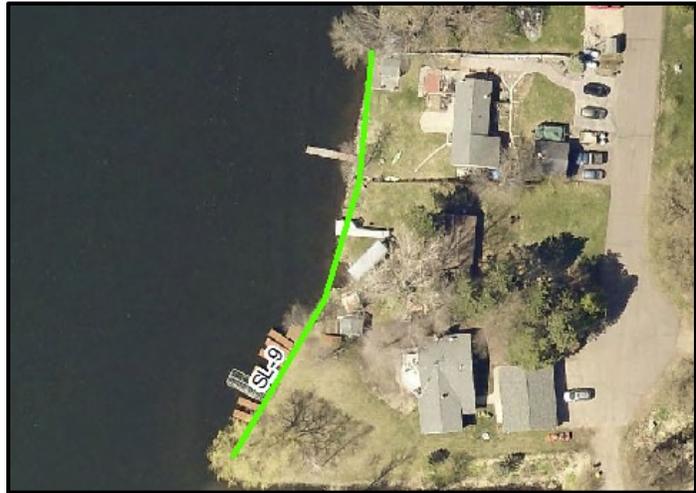
Shoreline 9: Description and Restoration Recommendation

Existing Shoreline Summary	
Watershed Acres	.6
Land Management	Lawn/rock
TP (lbs/yr)	.5
Shore Erosion Severity	Minimal

Location – Southeast shore of Skogman Lake

Project recommendation: Shoreline Restoration

For this section of shoreline, a basic shoreline restoration is proposed. Based on the shoreline characteristics, installing a native plant buffer along the shoreline will help capture and filter stormwater runoff from the watershed as well as stabilize the shoreline soils. In addition to the vegetative buffer, installing a biolog or willow bundles at the water’s edge will reduce soil loss and erosion from excessive wave action as well as encourage the success of the native plant buffer.

Shoreline Restorations		
Cost/Removal Analysis		
Treatment	Total Buffer Depth ft.	15
	Shoreline Addressed Lft.	192
	TP (lb/yr)	0.4
	TSS (lb/yr)	315
	Total Estimated Project Cost	\$15,400
Cost	Annual O&M***	\$50
	30-yr Average Cost/lb-TP	\$1,367

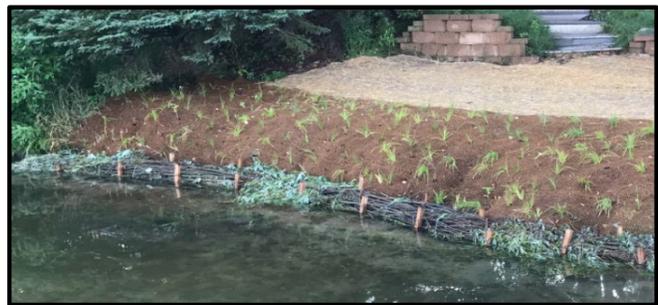
Native Plant Buffer and Willow Bundle Example

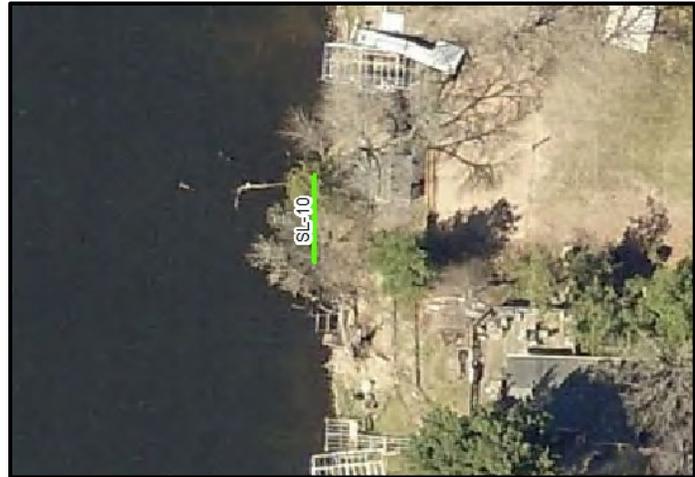
Shoreline 10: Description and Restoration Recommendation

Existing Shoreline Summary	
Watershed Acres	.5
Land Management	Lawn/Beach
TP (lbs/yr)	.07
Shore Erosion Severity	Moderate

Location – Southeast shore of Skogman Lake

Project recommendation: Shoreline Restoration

For this section of shoreline, a basic shoreline restoration is proposed. Based on the shoreline characteristics, installing a native plant buffer along the shoreline will help capture and filter stormwater runoff from the watershed as well as stabilize the shoreline soils. In addition to the vegetative buffer, installing a biolog or willow bundles at the water’s edge will reduce soil loss and erosion from excessive wave action as well as encourage the success of the native plant buffer.

Shoreline Restorations		
Cost/Removal Analysis		
Treatment	Total Buffer Depth ft.	15
	Shoreline Addressed Lft.	25
	TP (lb/yr)	0.06
	TSS (lb/yr)	44
	Total Estimated Project Cost	\$2,875
Cost	Annual O&M***	\$50
	30-yr Average Cost/lb-TP	\$2,387

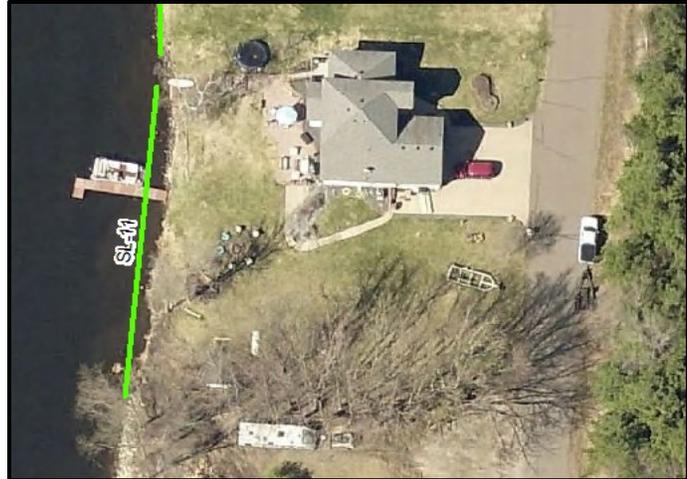
Shoreline 11:

Existing Shoreline Summary	
Watershed Acres	.8
Land Management	Lawn
TP (lbs/yr)	.6
Shore Erosion Severity	Moderate

Location – Southeast shore of Skogman Lake

Project recommendation: Shoreline Restoration

For this section of shoreline, a basic shoreline restoration is proposed. Based on the shoreline characteristics, installing a native plant buffer along the shoreline will help capture and filter stormwater runoff from the watershed as well as stabilize the shoreline soils. In addition to the vegetative buffer, installing a biolog or willow bundles at the water’s edge will reduce soil loss and erosion from excessive wave action as well as encourage the success of the native plant buffer.

Shoreline Restorations		
Cost/Removal Analysis		
Treatment	Total Buffer Depth ft.	15
	Shoreline Addressed Lft.	84
	TP (lb/yr)	0.4
	TSS (lb/yr)	280
	Total Estimated Project Cost	\$7,300
Cost	Annual O&M***	\$50
	30-yr Average Cost/lb-TP	\$811

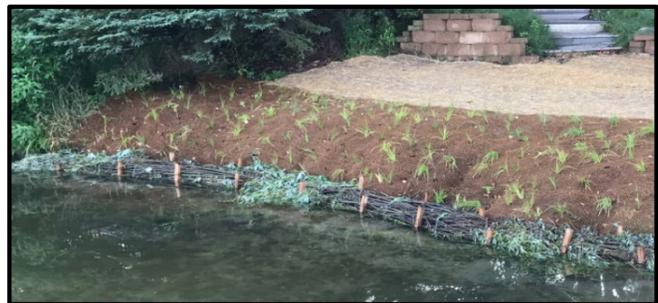
Native Plant Buffer and Willow Bundle Example

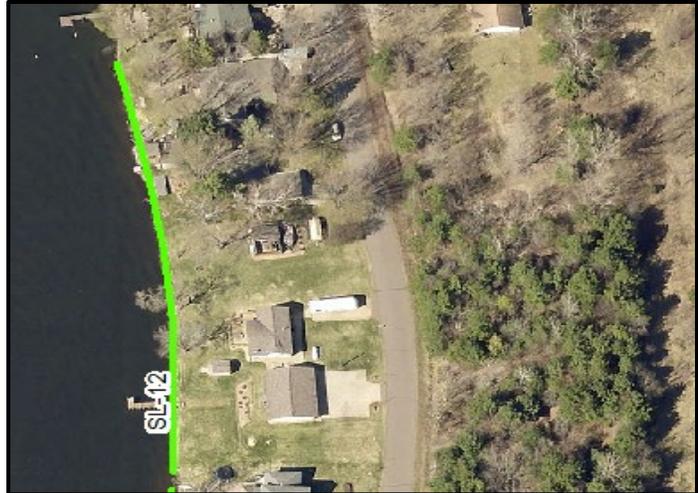
Shoreline 12: Description and Restoration Recommendation

Existing Shoreline Summary	
Watershed Acres	.8
Land Management	Lawn/rock
TP (lbs/yr)	.7
Shore Erosion Severity	Minimal

Location – Southeast shore of Skogman Lake

Project recommendation: Shoreline Restoration

For this section of shoreline, a basic shoreline restoration is proposed. Based on the shoreline characteristics, installing a native plant buffer along the shoreline will help capture and filter stormwater runoff from the watershed as well as stabilize the shoreline soils. In addition to the vegetative buffer, installing a biolog or willow bundles at the water’s edge will reduce soil loss and erosion from excessive wave action as well as encourage the success of the native plant buffer.

Shoreline Restorations		
Cost/Removal Analysis		
Treatment	Total Buffer Depth ft.	15
	Shoreline Addressed Lnft.	225
	TP (lb/yr)	0.5
	TSS (lb/yr)	391
	Total Estimated Project Cost	\$17,875
Cost	Annual O&M***	\$50
	30-yr Average Cost/lb-TP	\$1,242

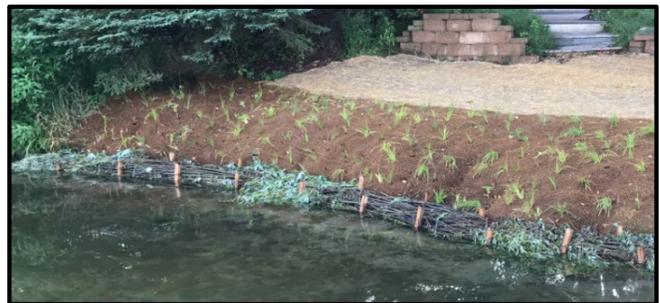
Native Plant Buffer and Willow Bundle Example

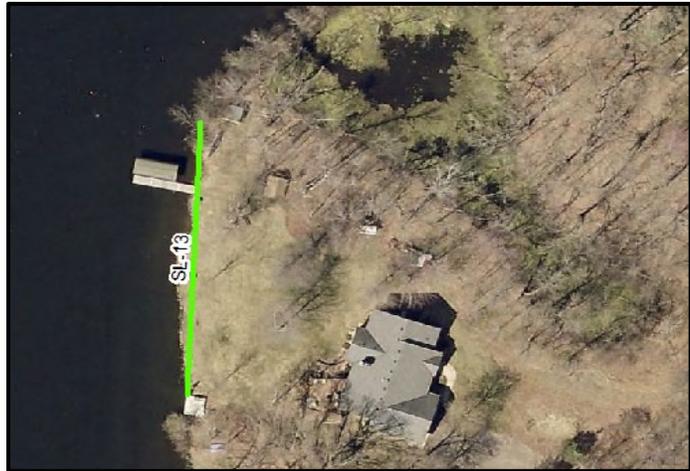
Shoreline 13:

Existing Shoreline Summary	
Watershed Acres	2.4
Land Management	Lawn/rock
TP (lbs/yr)	.4
Shore Erosion Severity	Minimal

Location – Southeast shore of Skogman Lake

Project recommendation: Shoreline Restoration

For this section of shoreline, a basic shoreline restoration is proposed. Based on the shoreline characteristics, installing a native plant buffer along the shoreline will help capture and filter stormwater runoff from the watershed as well as stabilize the shoreline soils. In addition to the vegetative buffer, installing a biolog or willow bundles at the water’s edge will reduce soil loss and erosion from excessive wave action as well as encourage the success of the native plant buffer.

Shoreline Restorations		
Cost/Removal Analysis		
Treatment	Total Buffer Depth ft.	15
	Shoreline Addressed Lft.	98
	TP (lb/yr)	0.3
	TSS (lb/yr)	178
	Cost	Total Estimated Project Cost
Annual O&M***		\$50
Efficiency	30-yr Average Cost/lb-TP	\$1,161

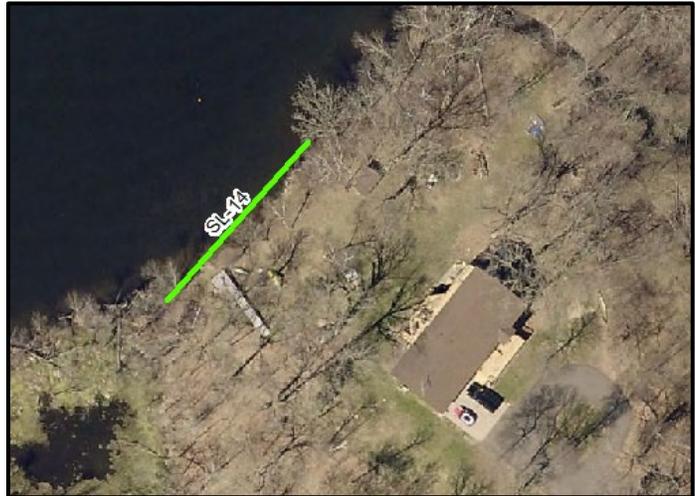
Shoreline 14: Description and Restoration Recommendation

Existing Shoreline Summary	
Watershed Acres	.1
Land Management	Lawn/rock
TP (lbs/yr)	.35
Shore Erosion Severity	Minimal

Location – Southeast shore of Skogman Lake

Project recommendation: Shoreline Restoration

For this section of shoreline, a basic shoreline restoration is proposed. Based on the shoreline characteristics, installing a native plant buffer along the shoreline will help capture and filter stormwater runoff from the watershed as well as stabilize the shoreline soils. In addition to the vegetative buffer, installing a biolog or willow bundles at the water’s edge will reduce soil loss and erosion from excessive wave action as well as encourage the success of the native plant buffer.

Shoreline Restorations		
Cost/Removal Analysis		
Treatment	Total Buffer Depth ft.	15
	Shoreline Addressed Lft.	70
	TP (lb/yr)	0.3
	TSS (lb/yr)	363
	Total Estimated Project Cost	\$6,250
Cost	Annual O&M***	\$50
	30-yr Average Cost/lb-TP	\$935

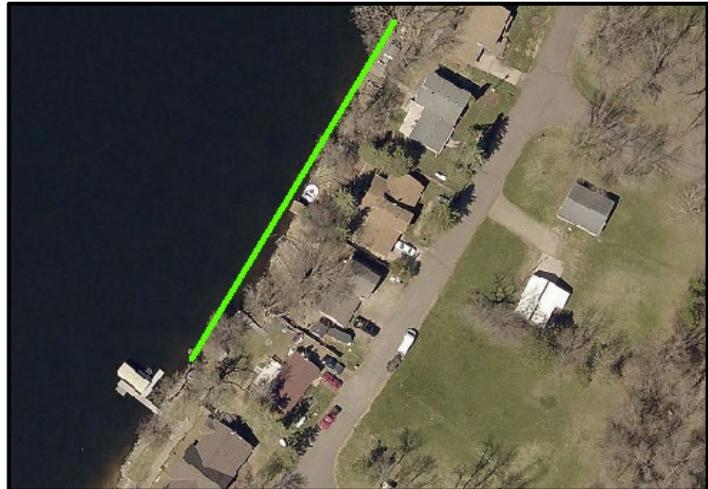
Shoreline 15:

Existing Shoreline Summary	
Watershed Acres	.53
Land Management	Lawn/rock
TP (lbs/yr)	.62
Shore Erosion Severity	Minimal

Location – Southeast shore of Skogman Lake

Project recommendation: Shoreline Restoration

For this section of shoreline, a basic shoreline restoration is proposed. Based on the shoreline characteristics, installing a native plant buffer along the shoreline will help capture and filter stormwater runoff from the watershed as well as stabilize the shoreline soils. In addition to the vegetative buffer, installing a biolog or willow bundles at the water’s edge will reduce soil loss and erosion from excessive wave action as well as encourage the success of the native plant buffer.

Shoreline Restorations		
Cost/Removal Analysis		
Treatment	Total Buffer Depth ft.	15
	Shoreline Addressed Lft.	192
	TP (lb/yr)	0.5
	TSS (lb/yr)	546
	Total Estimated Project Cost	\$15,400
Cost	Annual O&M***	\$50
	Efficiency	
	30-yr Average Cost/lb-TP	\$1,055

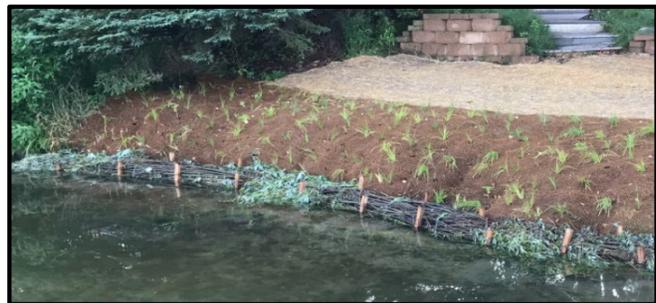
Native Plant Buffer and Willow Bundle Example

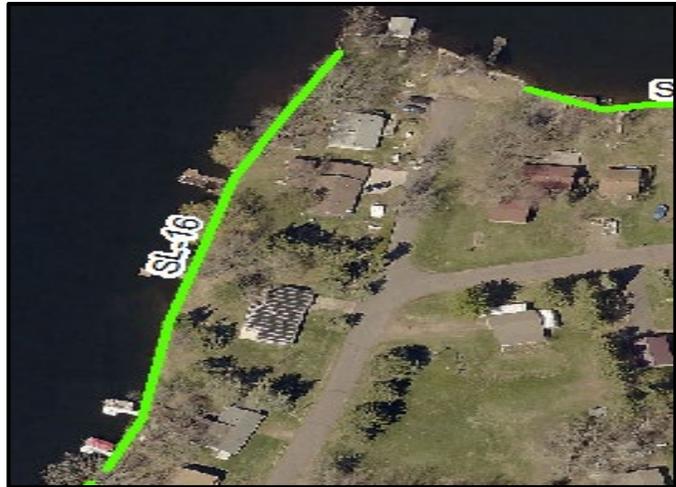
Shoreline 16:

Existing Shoreline Summary	
Watershed Acres	1.0
Land Management	Lawn
TP (lbs/yr)	.9
Shore Erosion Severity	Minimal

Location – Southeast shore of Skogman Lake

Project recommendation: Shoreline Restoration

For this section of shoreline, a basic shoreline restoration is proposed. Based on the shoreline characteristics, installing a native plant buffer along the shoreline will help capture and filter stormwater runoff from the watershed as well as stabilize the shoreline soils. In addition to the vegetative buffer, installing a biolog or willow bundles at the water’s edge will reduce soil loss and erosion from excessive wave action as well as encourage the success of the native plant buffer.

Shoreline Restorations		
Cost/Removal Analysis		
Treatment	Total Buffer Depth ft.	15
	Shoreline Addressed Lft.	330
	TP (lb/yr)	0.7
	TSS (lb/yr)	545
	Total Estimated Project Cost	\$25,750
Cost	Annual O&M***	\$50
	30-yr Average Cost/lb-TP	\$1,300

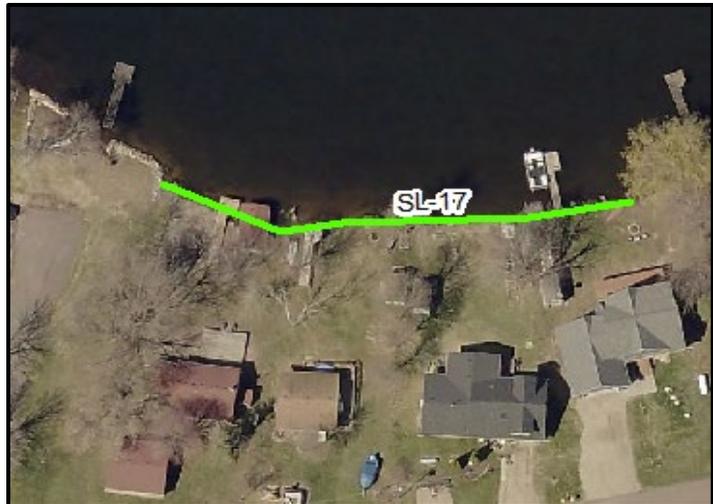
Shoreline 17: Description and Restoration Recommendation

Existing Shoreline Summary	
Watershed Acres	1.03
Land Management	Lawn
TP (lbs/yr)	.9
Shore Erosion Severity	Mild

Location – Southeast shore of Skogman Lake

Project recommendation: Shoreline Restoration

For this section of shoreline, a basic shoreline restoration is proposed. Based on the shoreline characteristics, installing a native plant buffer along the shoreline will help capture and filter stormwater runoff from the watershed as well as stabilize the shoreline soils. In addition to the vegetative buffer, installing a biolog or willow bundles at the water’s edge will reduce soil loss and erosion from excessive wave action as well as encourage the success of the native plant buffer.

Shoreline Restorations		
Cost/Removal Analysis		
Treatment	Total Buffer Depth ft.	15
	Shoreline Addressed Lnft.	140
	TP (lb/yr)	0.7
	TSS (lb/yr)	473
	Total Estimated Project Cost	\$11,500
Cost	Annual O&M***	\$50
	30-yr Average Cost/lb-TP	\$660

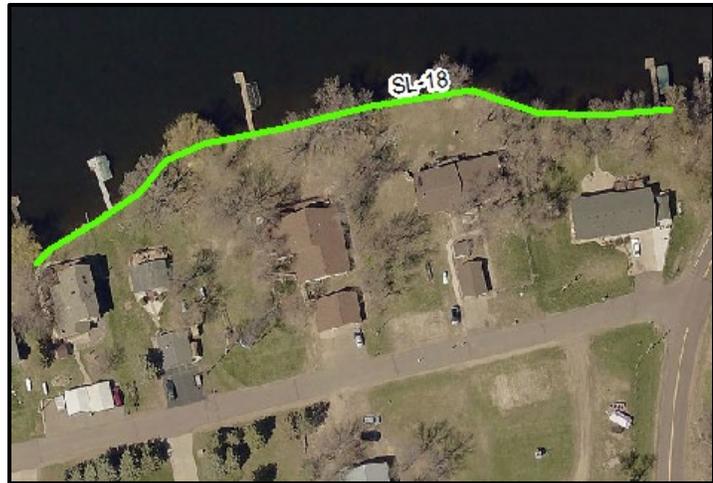
Shoreline 18:

Existing Shoreline Summary	
Watershed Acres	1.7
Land Management	Lawn/rock
TP (lbs/yr)	1.3
Shore Erosion Severity	Minimal

Location – Southeast shore of Skogman Lake

Project recommendation: Shoreline Restoration

For this section of shoreline, a basic shoreline restoration is proposed. Based on the shoreline characteristics, installing a native plant buffer along the shoreline will help capture and filter stormwater runoff from the watershed as well as stabilize the shoreline soils. In addition to the vegetative buffer, installing a biolog or willow bundles at the water’s edge will reduce soil loss and erosion from excessive wave action as well as encourage the success of the native plant buffer.

Shoreline Restorations		
Cost/Removal Analysis		
Treatment	Total Buffer Depth ft.	15
	Shoreline Addressed Lft.	387
	TP (lb/yr)	1.0
	TSS (lb/yr)	709
	Total Estimated Project Cost	\$30,025
Cost	Annual O&M***	\$50
	30-yr Average Cost/lb-TP	\$1,024
